Manhole Inspection Summary

Manhole # S13YY1003MH

Location Address: **2209 KEN OAK RD**

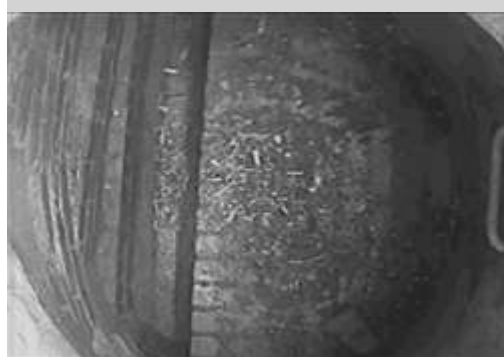
Top View

Bench ☒ Exists Material: **Brick** ☐ Parged ☒ **Debris** (not Condition related)

Bench debris.

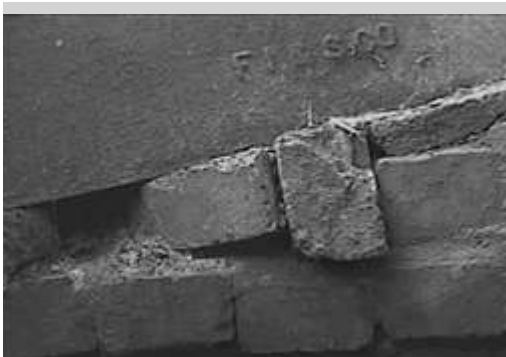
Defect

Frame Offset: **3.5** (in.) Condition: ☐ Sound ☐ Cracked ☒ **Leaks**

Condition: ☐ Sound ☐ Cracked ☐ Root Intrusion ☒ **Loose Brick** ☒ **Deteriorated**

Infiltration: ☐ None ☒ **Joint** ☐ Cracks ☒ **Mortar** ☐ Roots ☐ Wall

Frame leaks. Adjustment deterioration, loose brick, and infiltration.

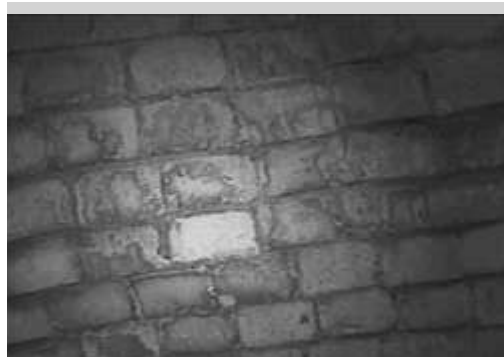
Defect

Infiltration: ☐ None ☐ Joint ☐ Cracks ☒ **Mortar** ☐ Roots ☒ **Wall**

Corbel and Barrel infiltration.

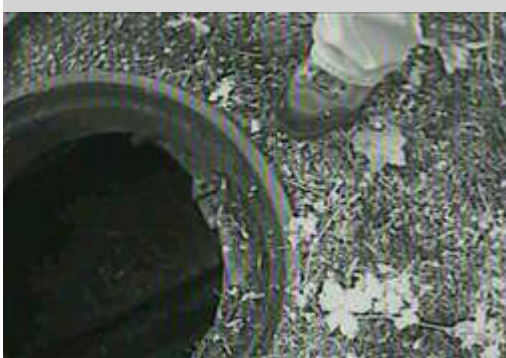
Defect

Frame offset.

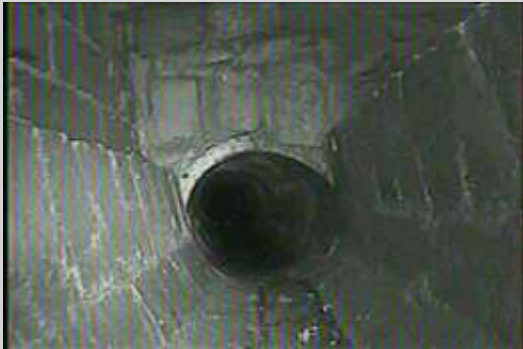
8 in. Circular Gravity Sewer Pipe Out @ 12 O'Clock

Infiltration: **Evidence** Pipe Seal Cond: **Cracked**

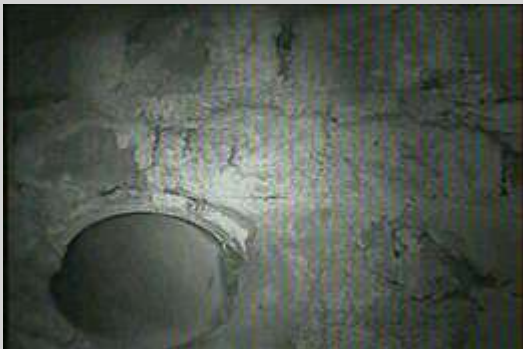
4 in. Circular Gravity Sewer Pipe In @ 6 O'Clock

Infiltration: **Evidence** Pipe Seal Cond: **Unknown**
